INDOOR AIR QUALITY ASSESSMENT

**Jacobs Elementary School
180 Harbor View Road
Hull, Massachusetts 02405**

Prepared by:
Massachusetts Department of Public Health
Center for Environmental Health
Emergency Response/Indoor Air Quality Program
October 2006

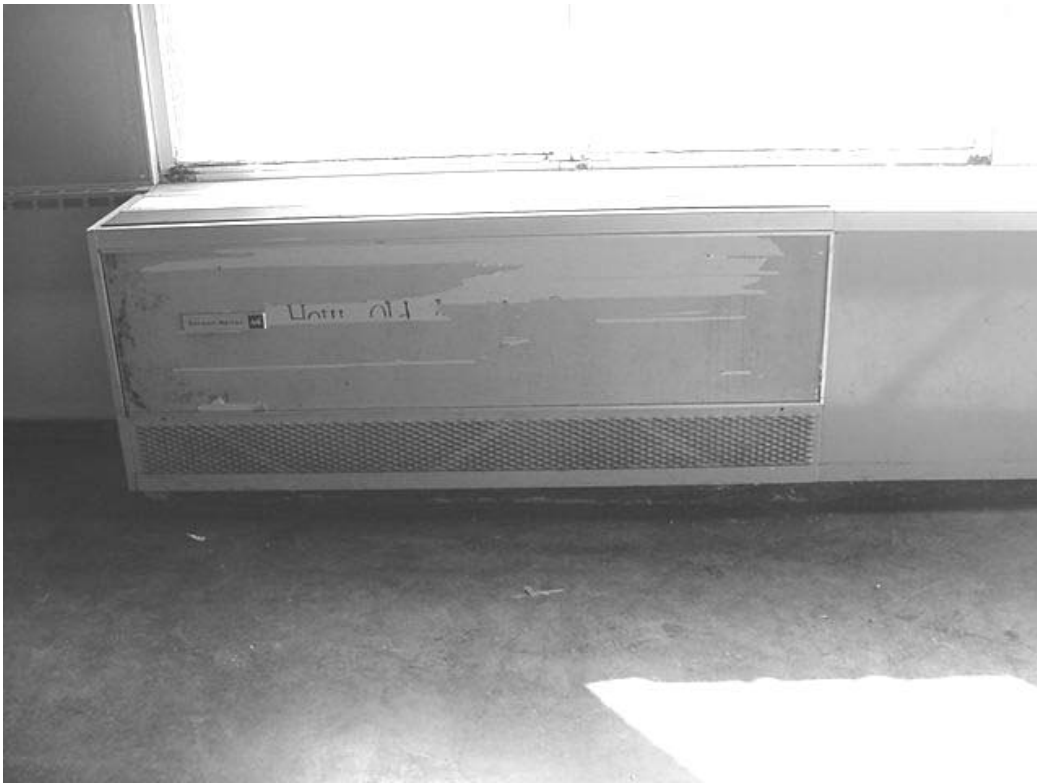
Picture 1

Fresh air in the majority of classrooms is supplied by unit ventilators (univents) (Picture 1). A univent is designed to draw air from outdoors through a fresh air intake located on the exterior wall of the building (Picture 5). Return air is drawn through an air intake located at the base of each unit ([Figure 1](#)). Fresh and return air are mixed, filtered, heated and provided to classrooms through an air diffuser located in the top of the unit. Univents are original equipment to the building (approximately 40-50 years old). Efficient function of such aged equipment is difficult to maintain, since compatible replacement parts are often unavailable.

Original 1950's Univent, Tiles Removed from Floor

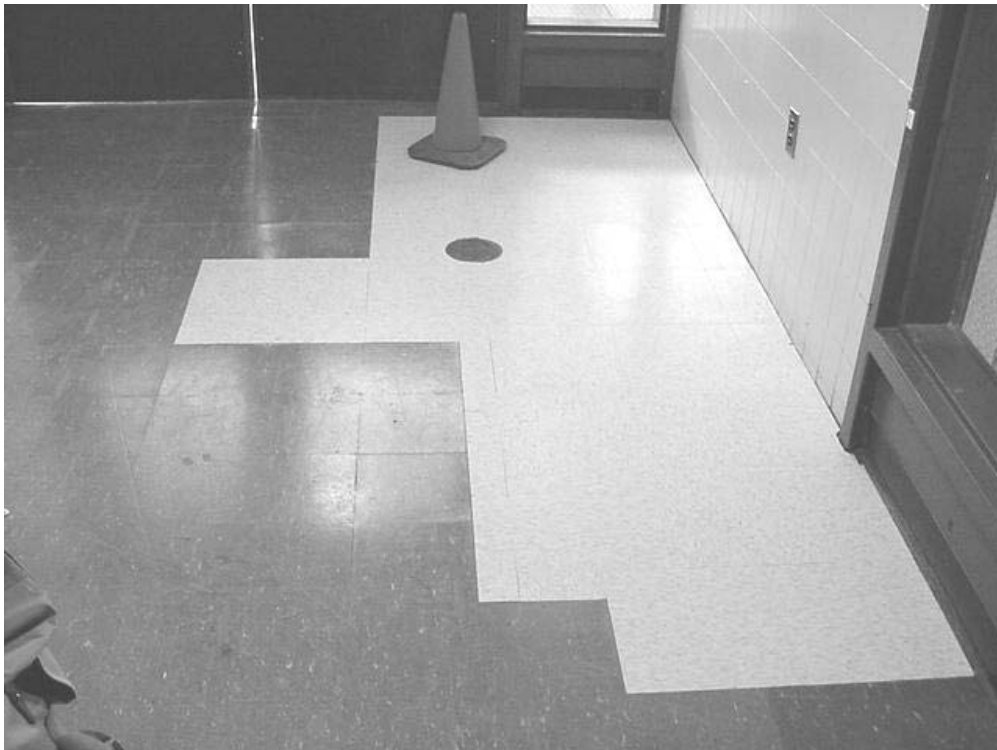
Picture 2

Mr. Twombly reported that during carpet removal asbestos concerns were raised regarding floor tiles in classrooms undergoing abatement. As a result, American Environmental Consultants, Inc. (AEC) was retained by the HPS to perform a reinspection to visually inspect and assess all friable and non-friable known or assumed asbestos-containing building materials (ACBM) in compliance with the US Environmental Protection Agency's (USEPA) Asbestos Hazard Emergency Response Act (AHERA) (40 CFR Part 763.85(b)). Based on their findings, AEC recommended that loose/buckling floor tiles be removed (AEC, 2006). Tiles were removed and floors were sealed in these and several other classrooms in conjunction with the mold abatement. Additional tiles were removed and replaced with vinyl floor tiles in the first floor main hallway (Picture 2).

Damaged ACBM Floor Tiles Replaced with Standard Vinyl Floor Tiles

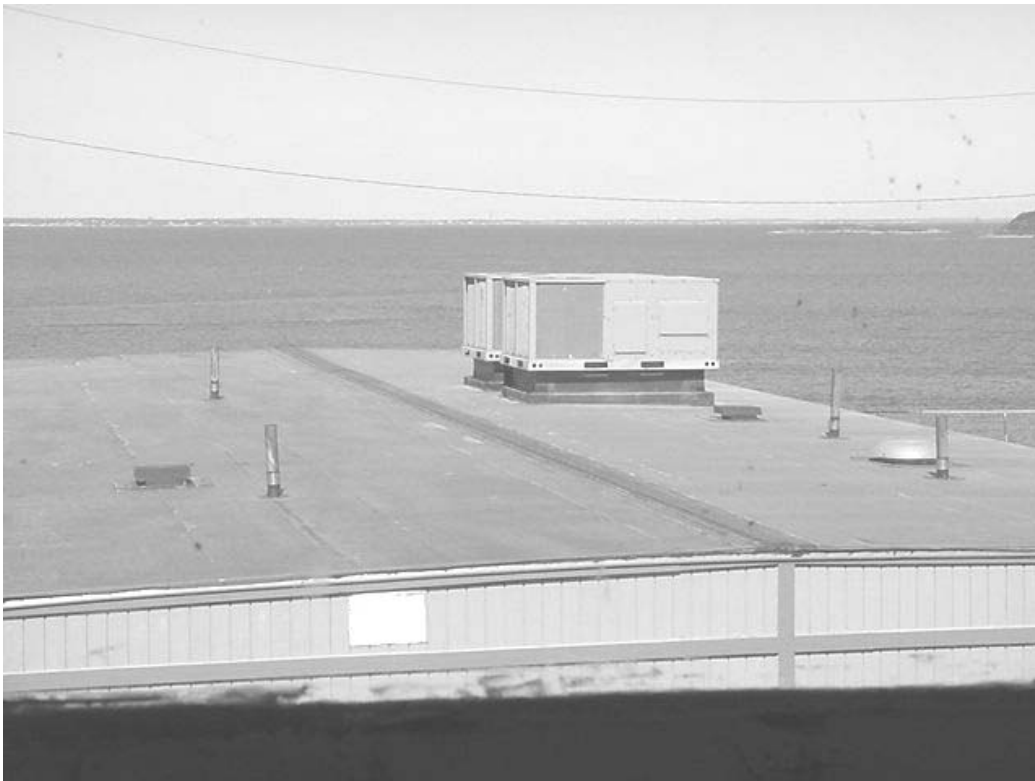
Picture 3

Ventilation for modular classrooms is provided by rooftop AHUs (Picture 3). Fresh air is distributed to classrooms via ductwork connected to ceiling-mounted air diffusers and drawn back to the AHUs through return grilles. Thermostats control each heating, ventilating and air conditioning (HVAC) system and have fan settings of “on” and “automatic”. Thermostats were set to the “automatic” setting (Picture 4) during the assessment. The automatic setting on the thermostat activates the HVAC system at a preset temperature. Once the preset temperature is reached, the HVAC system is deactivated. Therefore, no mechanical ventilation is provided until the thermostat re-activates the system. In addition, the AHUs were operating in air conditioning mode during the assessment, which can limit outside air intake on hot, humid days. Limiting outside air intake can contribute to an increase in carbon dioxide levels. The mechanical ventilation in the modular classroom office was not operating during the assessment.

Rooftop AHUs for Modular Classrooms

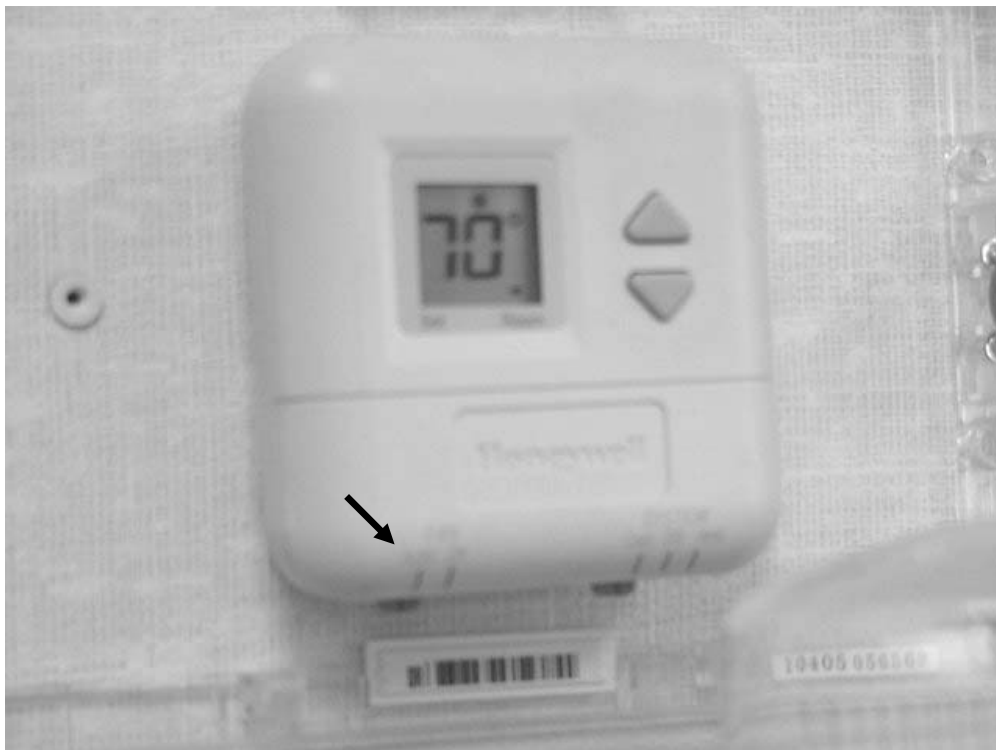
Picture 4

Modular Classroom Thermostat with Fan Switch in the “Auto” Position

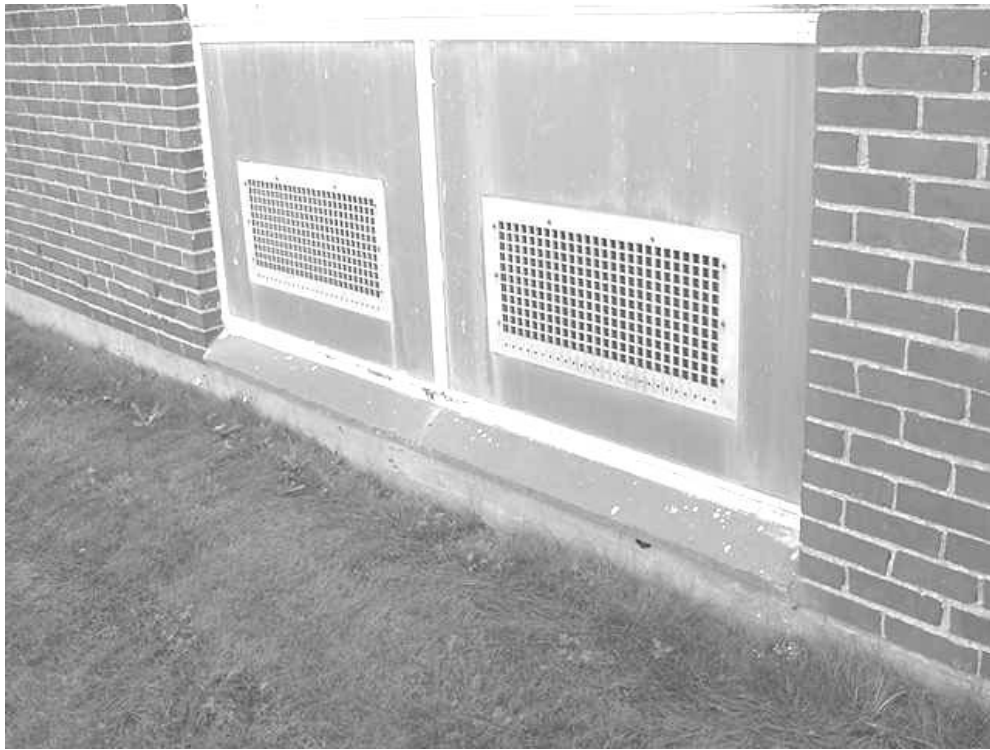
Picture 5

Univent Fresh Air Intakes

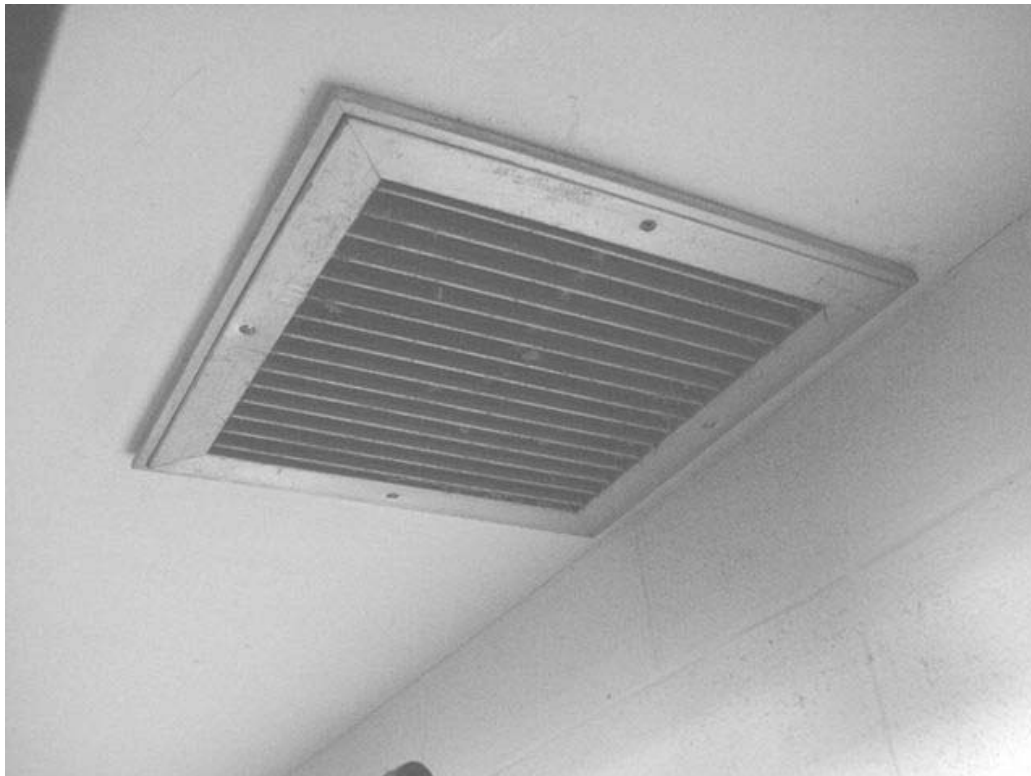
Picture 6

Exhaust ventilation is provided by vents located in the ceilings of coat closets (Picture 6), powered by rooftop motors. Air is drawn into the coat closet from the classroom via undercut

Exhaust Vent in Ceiling of Coat Closet

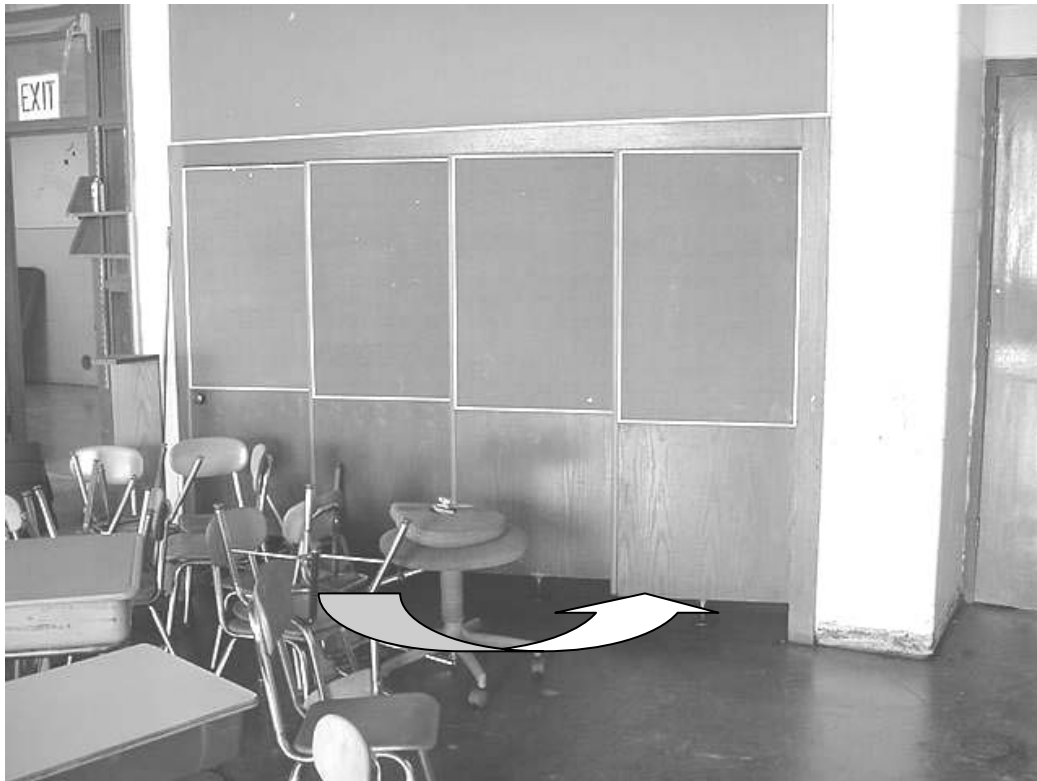
Picture 7

closet doors (Picture 7). MDPH staff did not detect any draw of air from the exhaust vents at the time of the assessment, which can indicate that they were deactivated or inoperable. The location of the closet vents also allows them to be easily blocked by stored materials.

Undercut Doors of Coat Closet Arrow Indicates Airflow

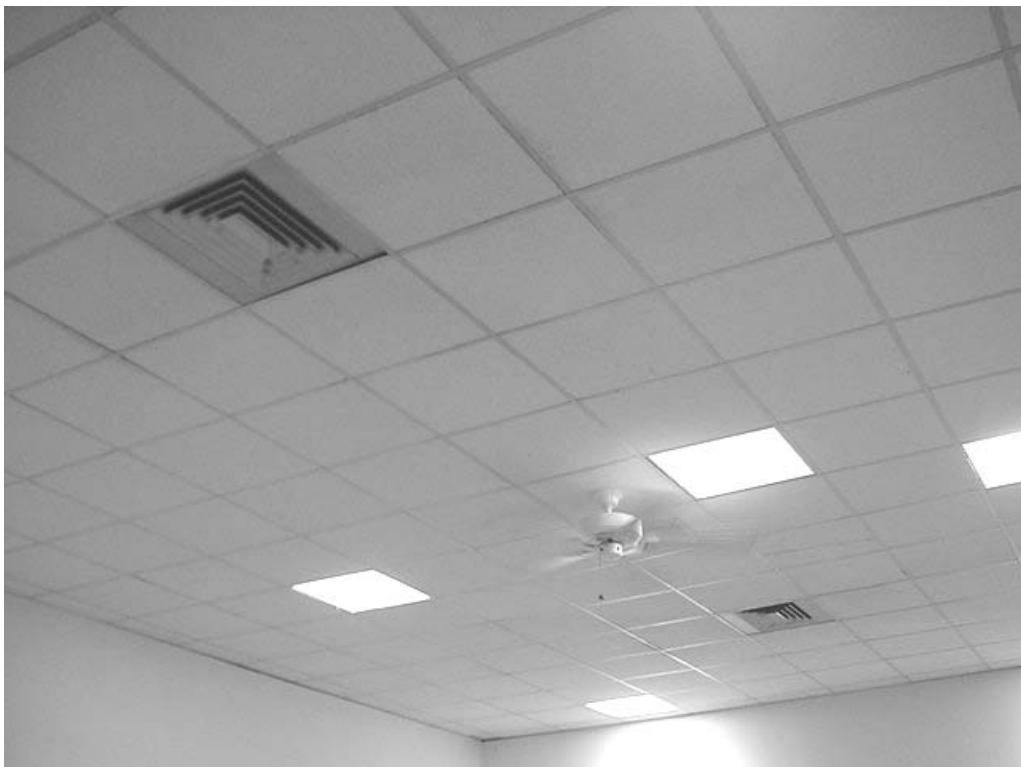
Picture 8

As previously mentioned, the cafeteria was reconfigured into four classrooms. Elevated carbon dioxide levels were measured in two of the four cafeteria classrooms (Table 1). Mechanical ventilation in the cafeteria provided by an AHU ducted to ceiling-mounted air diffusers (Picture 8). Exhaust ventilation is provided by wall-mounted exhaust vents. Although each of the four classrooms is equipped with supply ventilation, the division of the cafeteria has left two areas without exhaust ventilation. As with the univents, these systems were not operating during the assessment. The two classrooms below 800 ppm were located on the exterior wall and had windows open during the assessment. Without adequate supply and exhaust ventilation, excess heat and environmental pollutants can build up and lead to indoor air/comfort complaints. At the conclusion of the assessment CEH staff recommended to Principal Joyal and Mr. Twombly, that *all* mechanical ventilation systems be reactivated and that windows be used to supplement mechanical ventilation throughout the building (and in particular, the modular classroom wing) to introduce fresh outside air.

Ceiling-Mounted Air Diffusers and Ceiling Fans in Cafeteria Classrooms

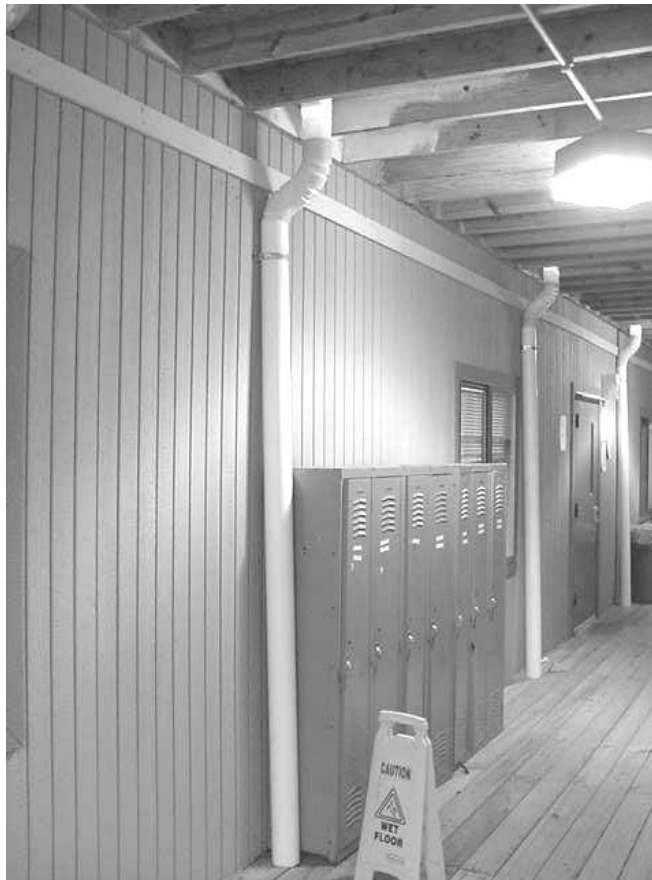
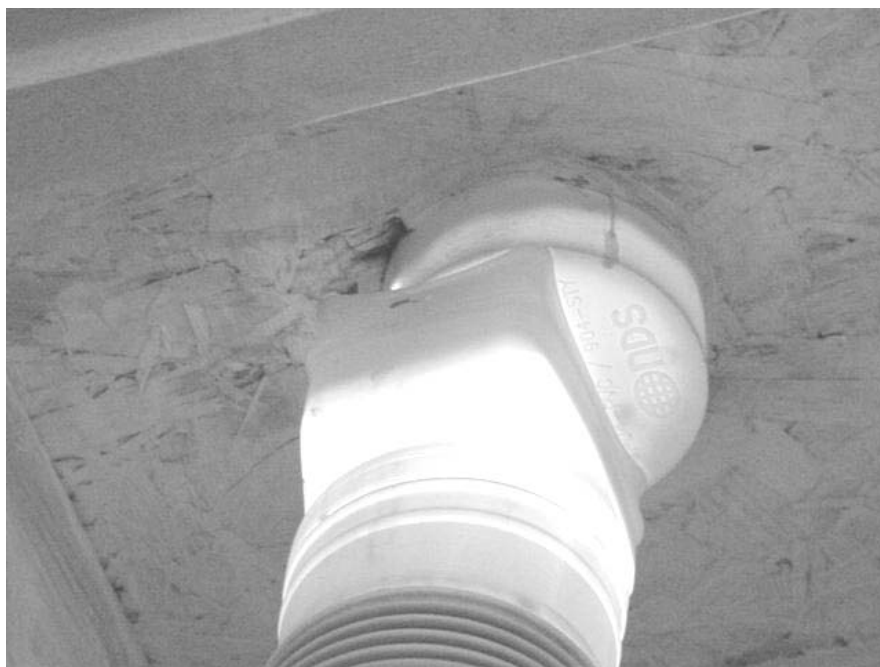
At the time of the assessment the building had undergone extensive mold remediation by OASIS. Occupants however, reported on-going concerns regarding leaks and odors in the modular classroom wing. Active leaks were reported from roof drains located inside the corridor of the modular classroom wing (Pictures 9 and 10). This was evidenced by standing water observed on top of student lockers below the drains, most likely resulting from rains that occurred in the Hull area the evening prior to the CEH assessment (Weather Underground, 2006). A small area that appeared to be mold growth was observed on the surface of a plastic drain pipe near the lockers (Picture 11). It was reported by Mr. Twombly that on-going attempts

Leaking Roof Drain inside Modular Hallway, Note Position of Student Lockers

Close-Up of Leaking Roof Drain inside Modular Hallway

7. Discard mold-contaminated books in MCO, conduct a thorough inspection of other materials and discard if water damaged/mold-colonized.
8. Make repairs to roof drains in modular classroom hallway.

9. Clean surface of plastic drain pipe shown in Picture 11 with an antimicrobial or mild detergent followed by soap and water.
10. Relocate lockers in the modular classroom hallway until roof drains are repaired.

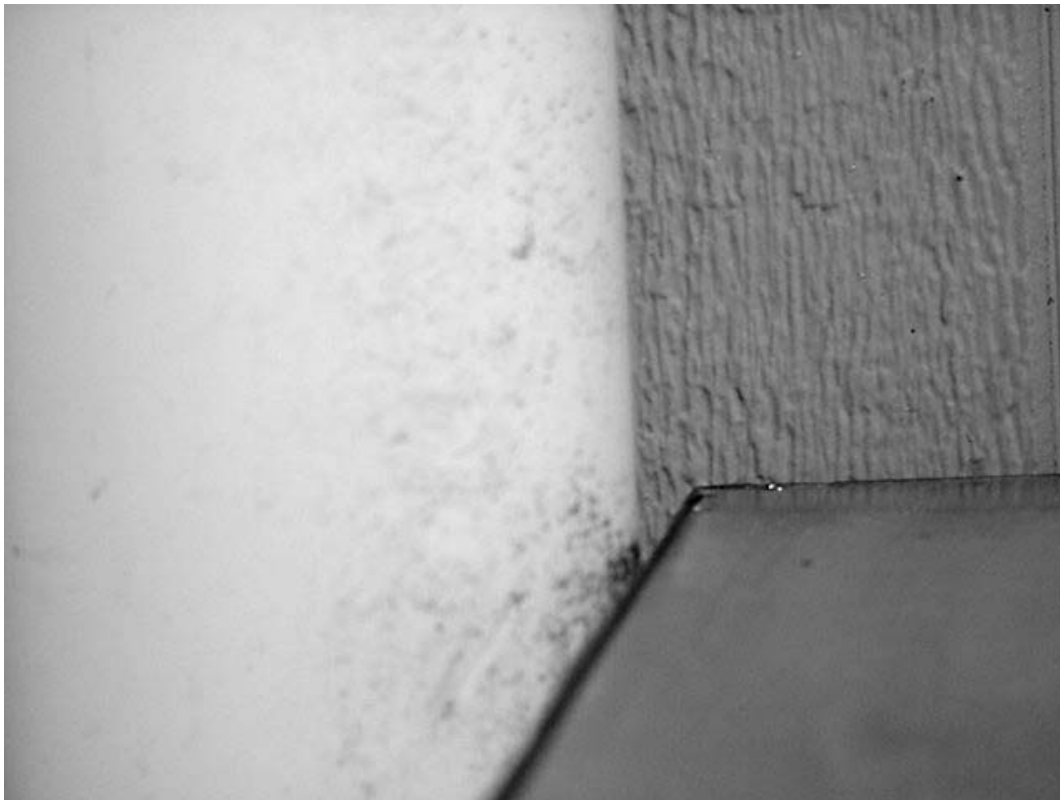
Picture 11

**Close-Up of Mold Growth on Surface of PVC Drainpipe
and Standing Water on top of Student Lockers (shown in Picture 9)**

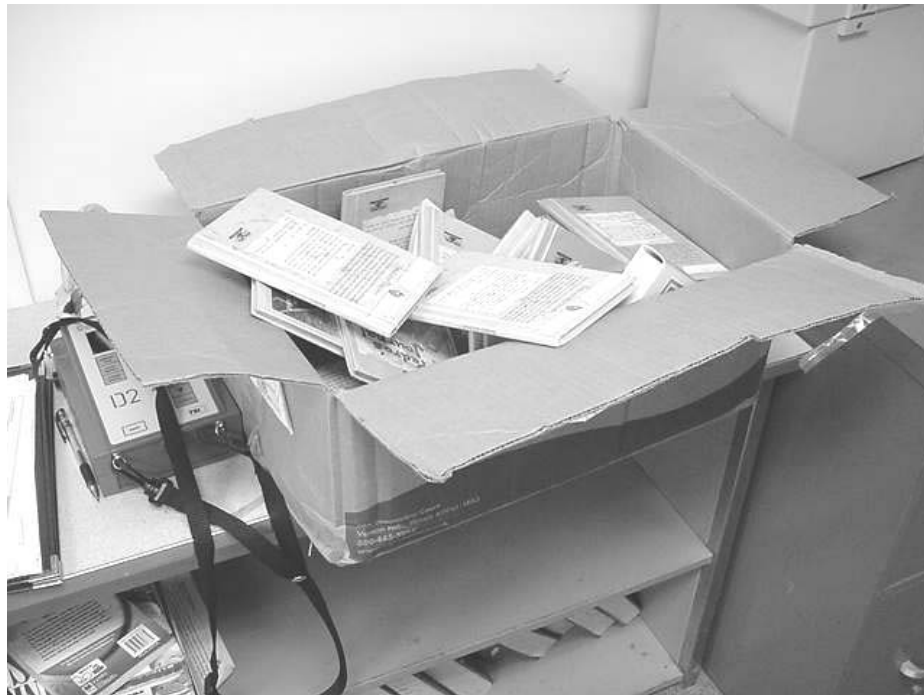
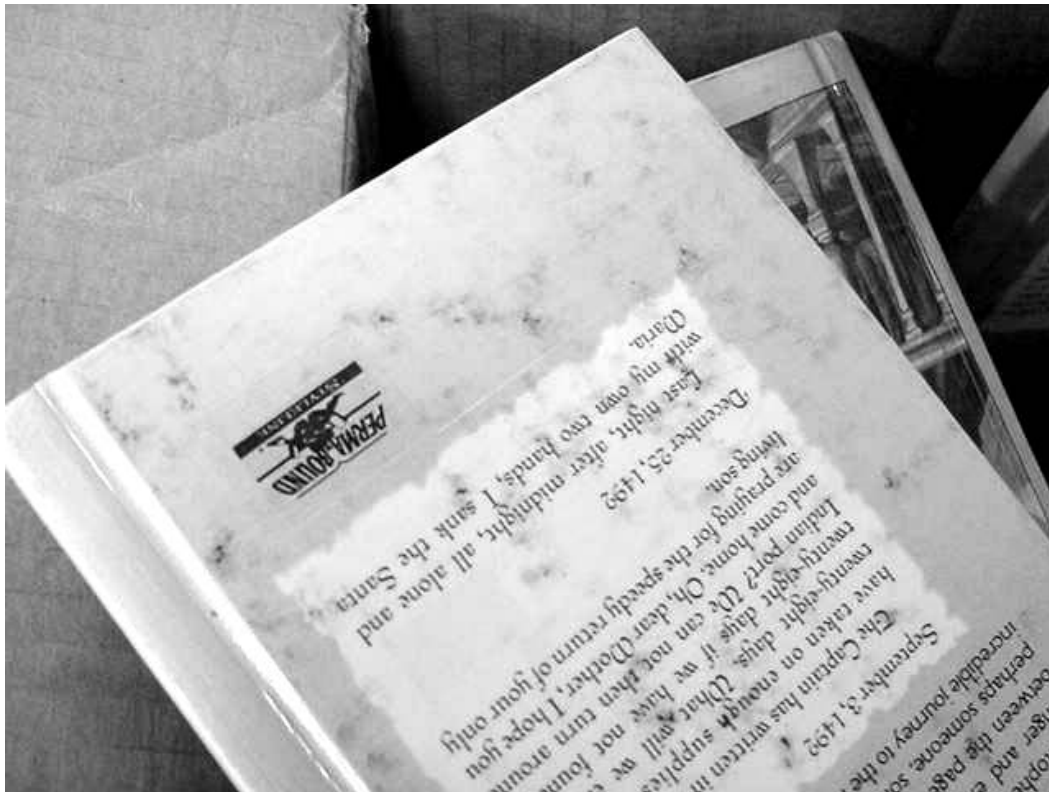
- A box containing a large number of mold-colonized books (Pictures 12 and 13);
- a strong odor of urine and other associated restroom odors in the boy's restroom that had no operating local exhaust ventilation (Picture 14);
- weakly operating local exhaust ventilation in the adult restroom, which would not be sufficient to remove odors;
- water damaged ceiling tiles in restrooms (Picture 14); and
- a water cooler on water-stained carpeting.

Box of Mold-Colonized Books in Modular Office

Close-Up of Mold-Colonized Books (as Indicated by Dark Stains) in Modular Office

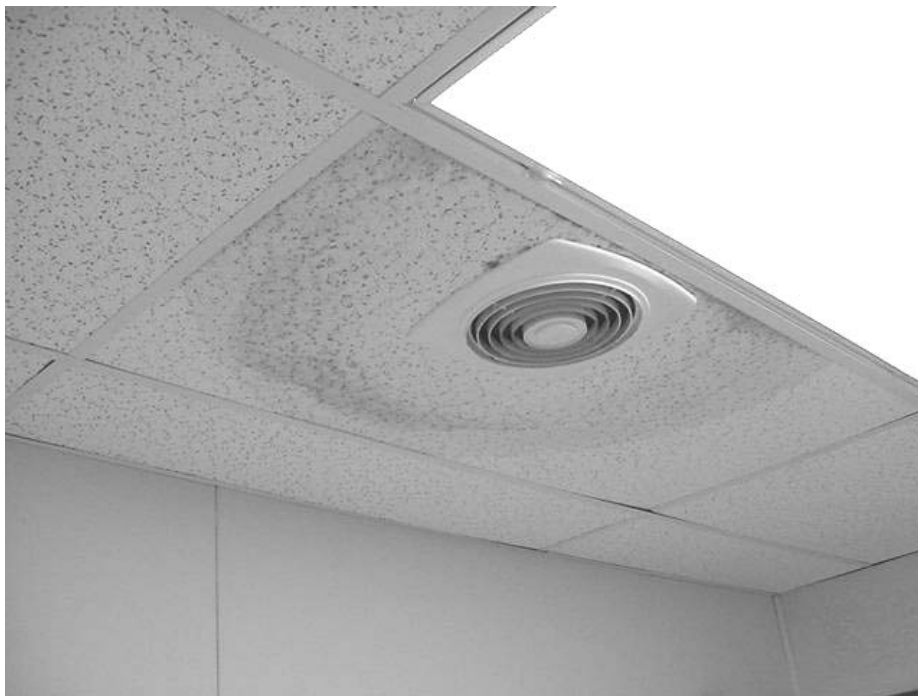
Picture 14

**Water Damaged Ceiling Tile and Inactive Local Exhaust Vent
in Modular Boy's Restroom**

6. Ensure leaks are repaired and replace water-damaged ceiling tiles. Examine the area above and around these areas for mold growth. Disinfect areas of water leaks with an appropriate antimicrobial.

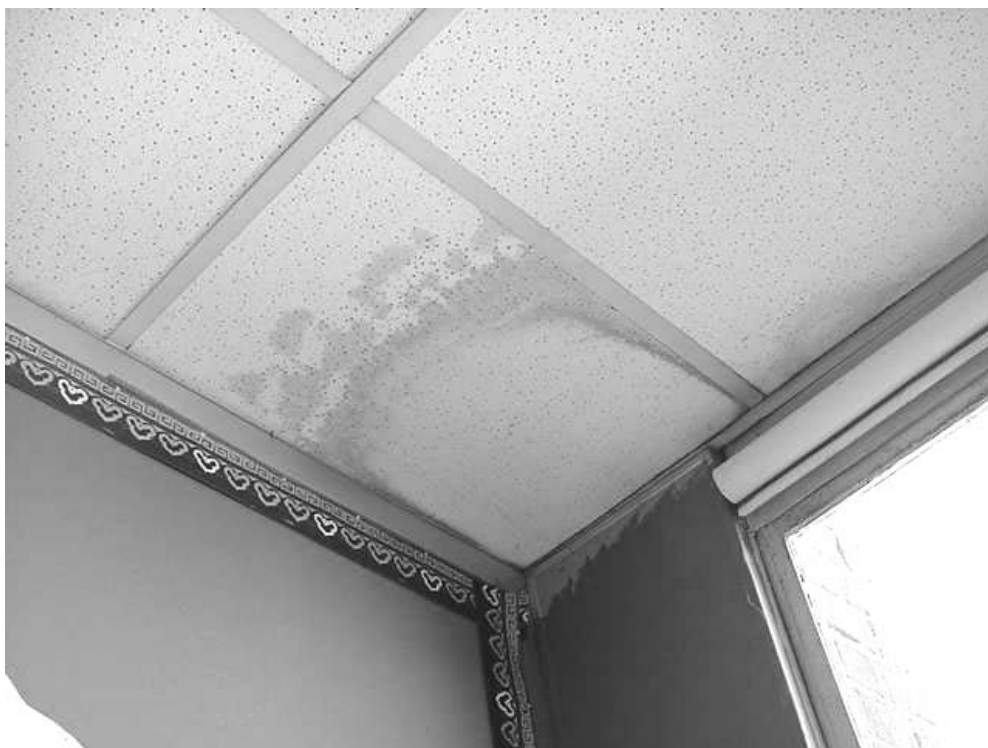
Picture 15

A few areas on both the first and second floor also had water-damaged ceiling tiles (Picture 15), which can indicate current or historic leaks from the roof or plumbing system. Water-damaged ceiling tiles can provide a source for mold growth and should be replaced after a water leak is discovered and repaired.

Water Damaged Ceiling Tile in Corner of Classroom

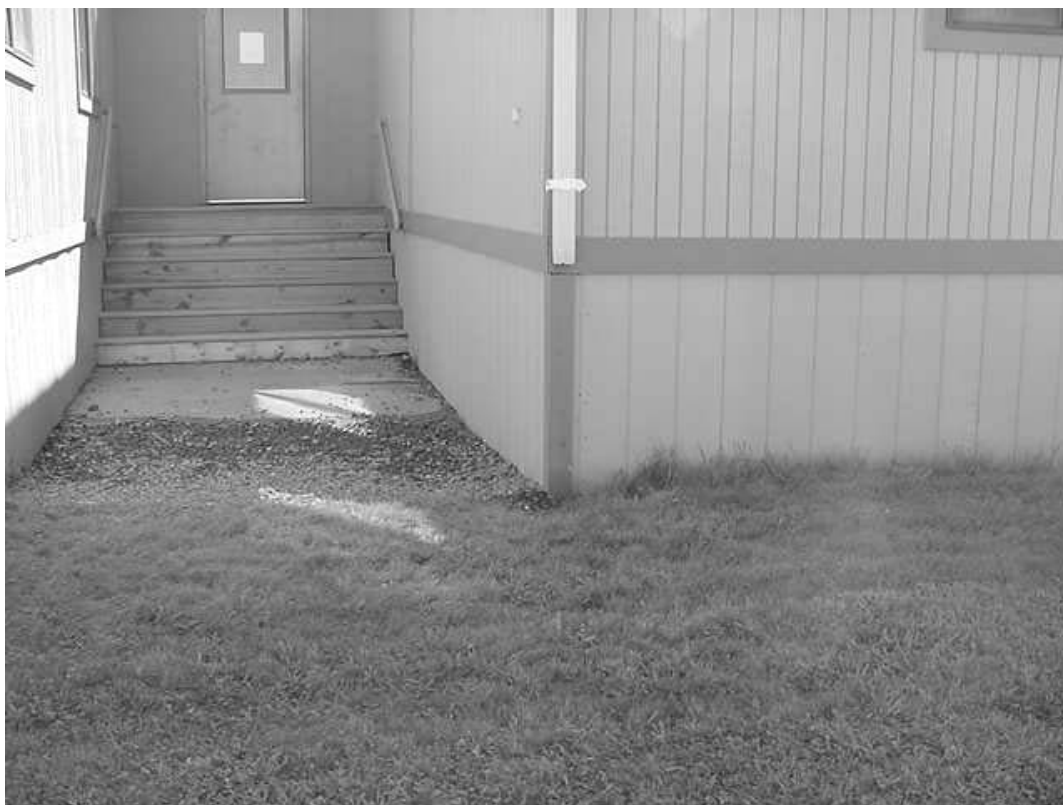
Picture 16

JES staff reported water infiltration in the modular classroom passageway, most likely from poor drainage. This condition has resulted in past water damage and mold growth on wooden passageway walls. In addition, JES staff reported that in the winter water freezes and creates a physical hazard inside the passageway. At the time of the assessment this area had been cleaned, disinfected and sealed by OASIS. CEH staff observed missing elbow extensions at the base of downspouts around the modular classroom wing (Picture 16). Gutters and downspouts are designed to collect and drain water *away* from the building.

Missing Elbow Extension at the Terminus of Downspout, Modular Classroom Wing

11. Install elbow extensions to the terminus of downspouts around the modular classroom wing to direct water *away* from the building.
12. Place tile or rubber matting underneath water coolers in carpeted areas. Inspect carpeted area below water cooler in MCO for mold and remove if colonized.

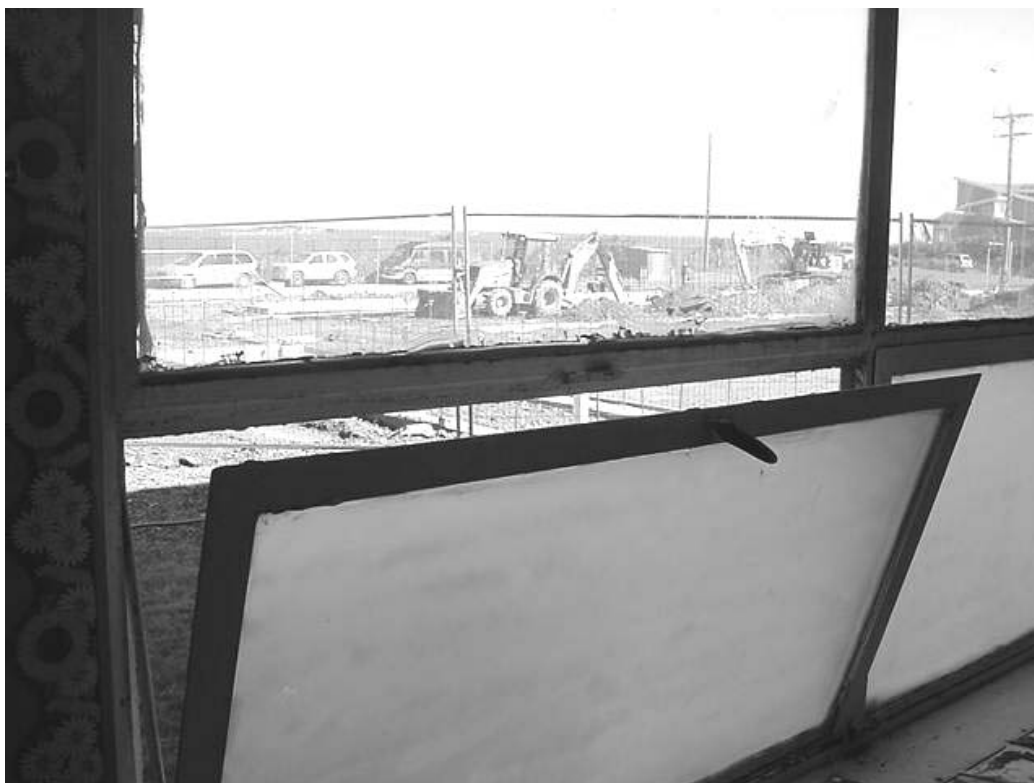
Picture 17

Concerns were raised about outdoor construction activities and their potential impact on indoor air quality. CEH staff observed a number of construction vehicles and several large piles of dirt/construction debris around the perimeter of the building (Pictures 17 and 18). This activity should be closely monitored to prevent the entrainment of vehicle exhaust and other fugitive dust/debris from construction from entering the building via unvents, open doors or windows. A number of classrooms adjacent to the construction zone had open windows during the assessment (Picture 17). The opening of windows allows for unfiltered air to enter the classroom environment carrying with it airborne dirt, dust and particulates. Thus, opening windows should be done with caution. Dusts can be irritating to the eyes, nose and respiratory tract.

Open Classroom Window, Note Construction Vehicles Operating Outside

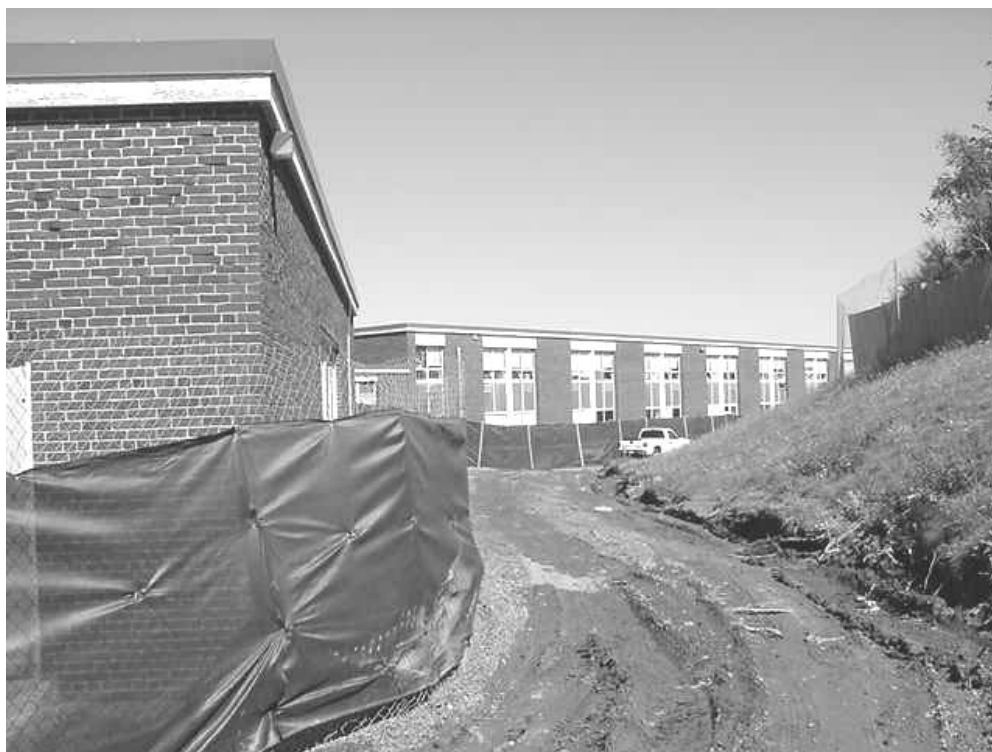
Picture 18

Dirt Construction Vehicle Access Road behind Building

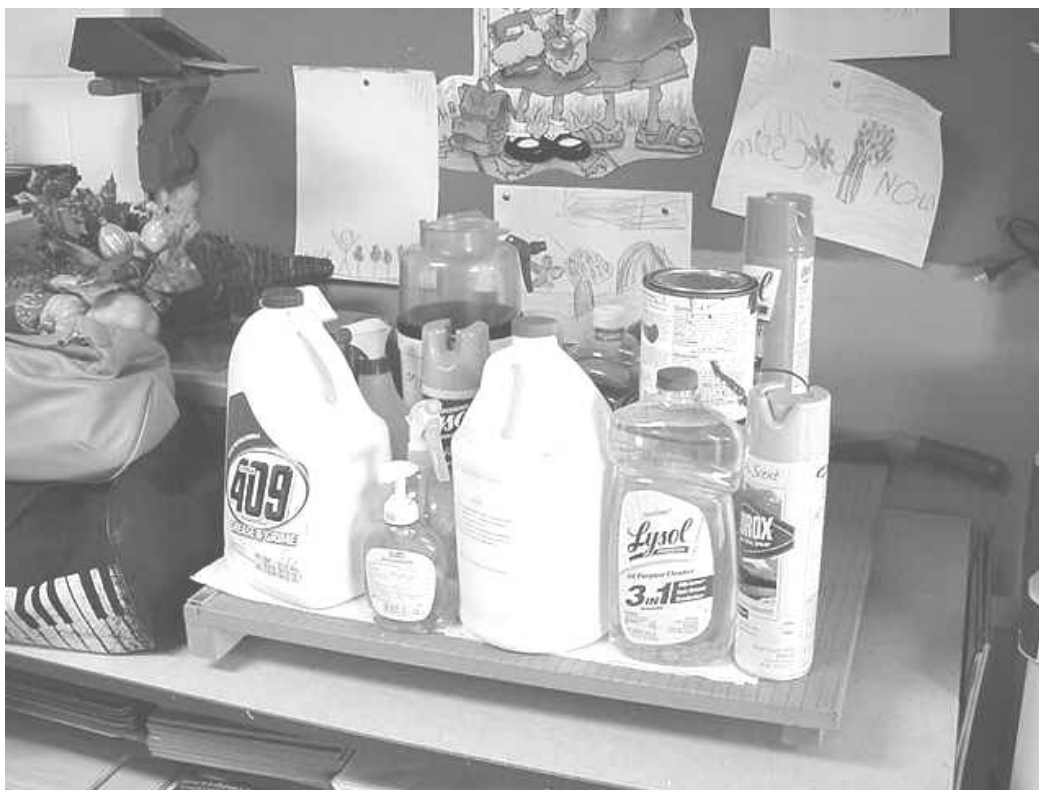
Picture 19

TVOC-containing products. While no measurable TVOC levels were detected in the indoor environment, VOC-containing materials were present in the building. Several classrooms contained dry erase boards and dry erase board markers. Materials such as dry erase markers and dry erase board cleaners may contain VOCs, such as methyl isobutyl ketone, n-butyl acetate and butyl-cellusolve (Sanford, 1999), which can be irritating to the eyes, nose and throat. Cleaning products and flammable materials were found on countertops and beneath sinks in a number of classrooms (Picture 19). Cleaning products contain VOCs and other chemicals, which can be irritating to the eyes, nose and throat and should be stored properly and kept out of reach of students.

Cleaning Products, Paint and Flammable Materials on Countertop in Classroom

14. Store cleaning products and chemicals properly and keep out of reach of students.
15. Clean air diffusers, exhaust/return vents and personal fan blades periodically of accumulated dust.

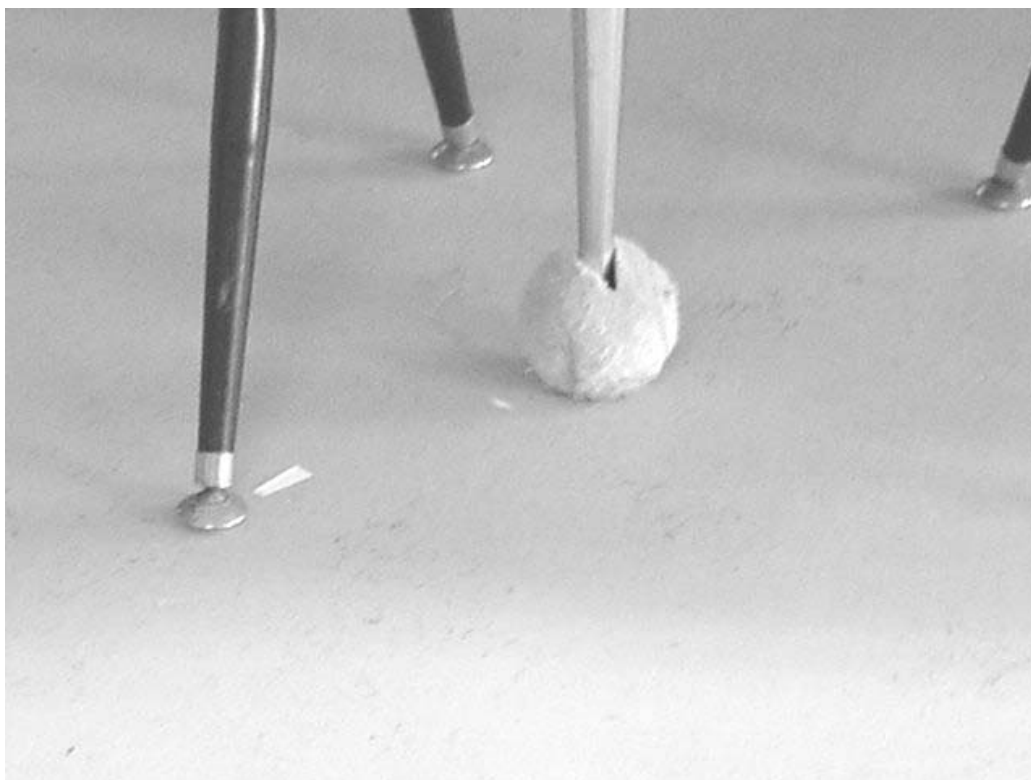
Picture 20

In an effort to reduce noise from sliding chairs, tennis balls had been sliced open and placed on chair legs in some areas (Picture 20). Tennis balls are made of a number of materials that are a source of respiratory irritants. Constant wearing of tennis balls can produce fibers and off gas VOCs. Tennis balls are made with a natural rubber latex bladder, which becomes abraded when used as a chair leg pad. Use of tennis balls in this manner may introduce latex dust into the school environment. Some individuals are highly allergic to latex (e.g., spina bifida patients) (SBAA, 2001). It is recommended that the use of materials containing latex be limited in buildings to reduce the likelihood of symptoms in sensitive individuals (NIOSH, 1997). A question and answer sheet concerning latex allergy is attached as Appendix B (NIOSH, 1998). Consider replacing tennis balls with alternative glides (Picture 21).

Tennis Ball on Chair Leg in Classroom

16. Consider discontinuing the use of tennis balls on furniture and replacing tennis balls with alternative “glides” as shown in Picture 21.
17. Develop a clear line of communication between the central maintenance department and school personnel for prompt remediation of temperature and/or ventilation concerns/complaints. This can be done by establishing a written request system (e.g., work order form) administered by a single responsible person see Appendix B as an example.

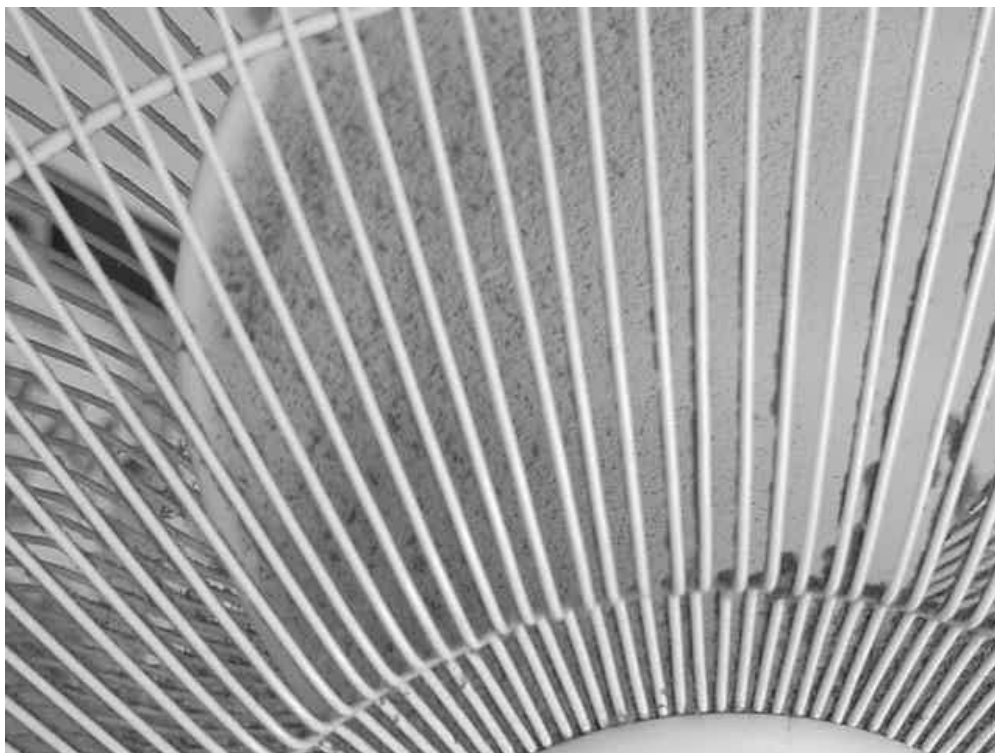
Picture 22

clean. Items should be relocated and/or be cleaned periodically to prevent excessive dust build-up. A number of fans/blades had accumulated dust (Picture 22). Fans should be cleaned periodically in order to prevent them from serving as a source of aerosolized particulates.

Dust Accumulation on Fan Blades in Classroom
